# COMPLEXITIES OF CURTAIN WALL FLANKING TRANSMISSION - A CASE STUDY

Kelly Kruger <sup>\*</sup>1, Robert Ogle<sup>†</sup>1

<sup>1</sup>Building Science Engineering, Edmonton, Alberta, Canada

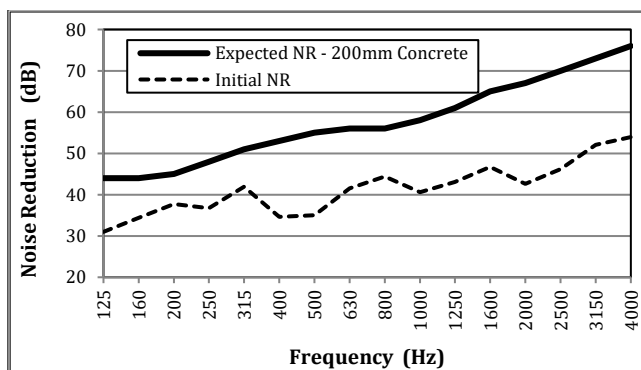
Figure 1: Expected vs measured noise reduction

The authors were recently involved in the acoustic commissioning of a university building where the sound isolation between floors was considered to be critical. A Noise Isolation Class of NIC 55 - 60 was required in order to allow music practice rooms to be located directly below conventional lecture rooms. Adequate acoustic isolation should have been achieved if the sound transmission was entirely determined by the 200 mm thick, post-tensioned concrete floor that separates the classrooms. The initial sound isolation, NIC 42, was found to be well below expectations, as shown on Figure 1.

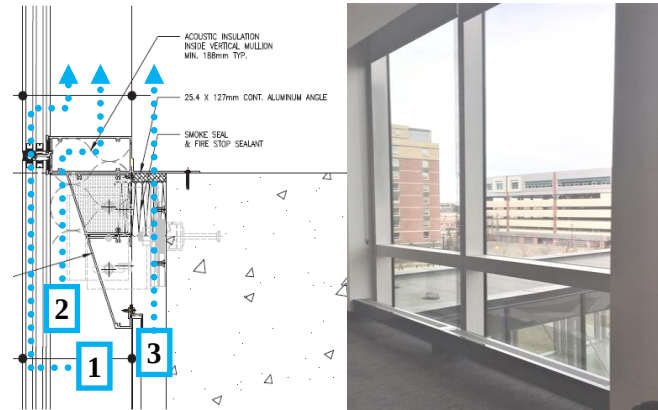
Figure 2: Curtain Wall Flanking Paths.

It was evident that there was significant flanking occurring at or near the building façade, made up of a unitized curtain wall assembly. Due to the complexity of the junction between the curtain wall and the floor structure, several potential flanking paths were identified. It was possible to alter each flanking path individually so that the incremental improvement of

Flanking can occur along several paths. Path 1 shows the transmission from the glazing on the lower floor level through the spacer and into the glazing on the upper floor. Path 2 shows the transmission directly through the horizontal mullion. Path 3 shows the transmission through the gap between the curtain wall and the floor slab.

An inspection of the curtain wall/floor junction revealed that the fire stop had not been fully installed (Flanking Path 3). This left a significant opening at the edge of the floor slab that was only blocked by carpeting. It was assumed that this gap was the most significant flanking path. It was therefore dealt with first by inserting two layers of fire resistant, mass loaded joint filler, with mineral wool inserted between layers. Treating Flanking Path 3 provided a modest improvement to NIC 46.

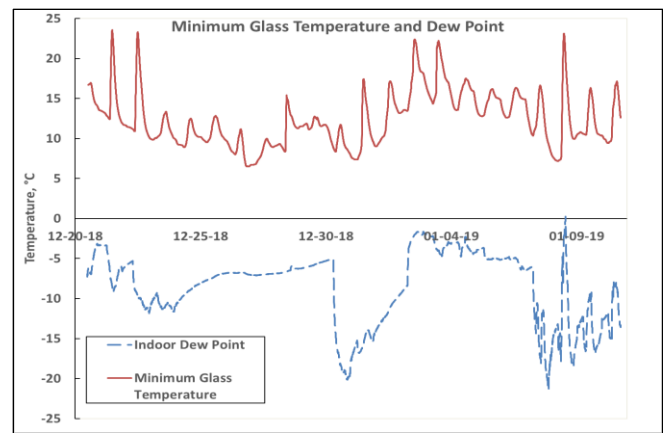
**Figure 3:** Minimum insulated glass temperature vs. dew point

In order to confirm if condensation would be problematic, temperature probes were used to monitor the glass temperature of both a typical existing IG unit, and an adjacent unit covered using gypsum board of roughly the same insulation value as the proposed inner glass panel. Data loggers were also used to measure the interior and exterior relative humidity (RH) for a period from December 20<sup>th</sup> 2018 to January 10<sup>th</sup> 2019. During this time, a minimum glass temperature of 6.5° C and a maximum dew point temperature of 0.2° C were measured (not concurrently) and are shown on Figure 3. Maximum interior RH levels during both occupied and unoccupied classroom times were found to be less than 25%. Using the collected data, a “worst case scenario” of a -30° C exterior temperature with interior conditions of 25° C and 25% RH was evaluated. In this scenario the dew point of the interior air was 3.6° C and the minimum glass temperature was 5° C. Therefore under these design conditions, condensation would not occur.

Given these findings we concluded that the introduction of the interior glass panels would not result in condensation problems.

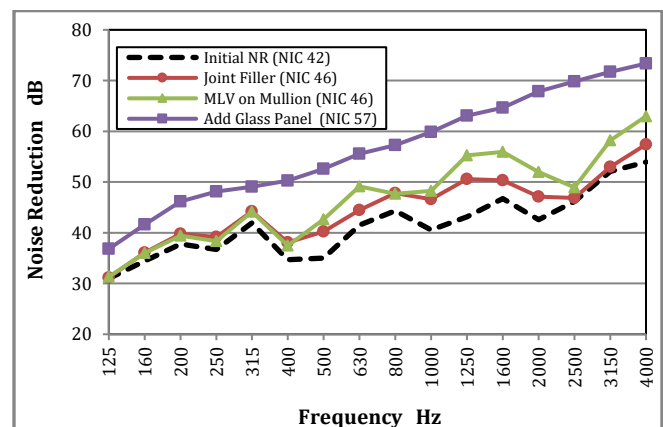
**Figure 4:** Improvement due to treatment of Flanking Paths

Figure 4 summarizes the improvement that occurred after each step of mitigating the flanking through the various paths. Some flanking from the curtain wall is still evident but any further modifications to the existing construction are no longer thought to be practical.

Finally, a new glass panel was installed to cover the entire lower section of the curtain wall, thereby reducing the contribution of the last major flanking path. The lower mullions were clad with a layer of MLV that incorporated a sound absorptive foam layer exposed to the cavity between the curtain wall and the new glass panel. A significant improvement in sound isolation (NIC 57) was achieved.
